## Brake Drums

# Brakes - troubleshooting guide

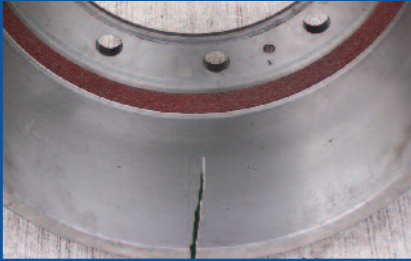
### Cracked Drums

Upon inspecting the drum, a crack has been discovered which extends through the entire wall, this condition is caused by excessive heating and cooling of the brake drum during operation. If this fault is discovered the drum must be replaced immediately. Repeated cracking of the drums may indicate either a brake system fault or driver abuse. If this problem occurs, close attention must be paid to the brake system balance and brake lining friction ratings as specified by the original equipment manufacturer.

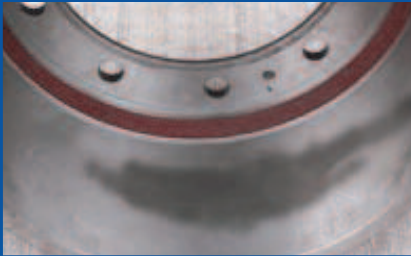
### Grease Stained Drums

If this condition is apparent, the brake drum will show discolouration on the braking surface. This condition is normally associated with a faulty lubrication system or improper greasing of the brake cams. Once the source of the contamination has been identified and remedied, thorough cleaning of the components must be carried out, and any contaminated brake linings must be replaced.

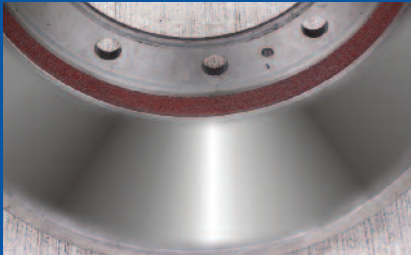
### Polished Brake Drums

Polished drums can be identified by a mirror-like finish on the braking surface. This problem can be remedied by lightly sanding both the lining and brake drum surface with some medium grit emery cloth. The brake system should be checked for lightly dragging brakes and the linings should be checked to ensure the correct material is being used. We recommend that the braking surface is sanded each time the linings are replaced.

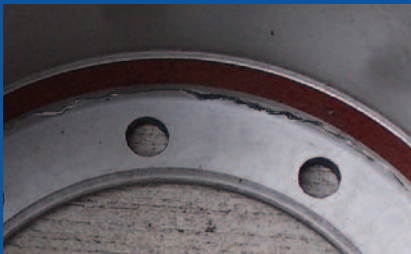
### Broken Mounting Ring

This problem occurs when there is interference between the hub and drum mounting surface, due to incorrect seating of the drum on the hub during installation, a damaged hub, or a build up of corrosion on the hub. Prior to brake drum replacement the hub should be visually checked and any defects rectified, by either cleaning up the hub or replacing where necessary. If any cracks are identified in the bolt circle or mounting surface the drum must be replaced.

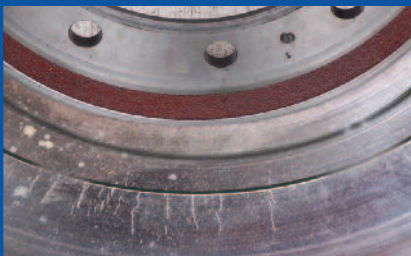
### Scored Brake Drums

This problem is indicated by defined grooves in the braking surface of the drum and excessive brake lining wear. These grooves are caused by either the brake linings being completely worn out causing a metal to metal situation, or a foreign body finding its way inside the brake drum area.

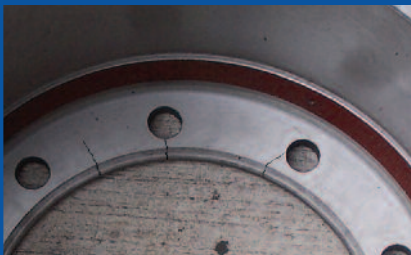
### Radial Cracking of the Mount Surface

This condition is caused by interference between the hub and drum mounting surface during installation as a result of using the wrong drum for the application or improperly cleaning the hub piloting surface prior to drum installation. If this condition exists the drum must be replaced. Check the application to determine the proper drum for the application before attempting to install a replacement drum. Visually inspect the hub piloting surface and make sure that all the dirt and corrosion are properly removed. Also take care when installing the drum to make sure the mounting surface is properly and evenly seated against the hub mounting surface before torquing the wheel nuts during assembly.

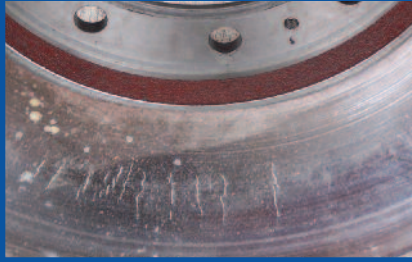
## Heat-Checks

Heat-checking presents itself as a number of short, fine, hairline cracks on the braking surface of the drum. Heat-checking is a normal characteristic found in brake drums and is caused by constant cooling and heating of the braking surface, which occurs when the brakes are applied during everyday operation of the vehicle. Normal heat-checking will not impair braking performance. Heat-checks will ordinarily wear away and reform as a result of the normal braking process, however heat-checks may progress over time into more serious cracks, which will require the brake drum to be replaced.

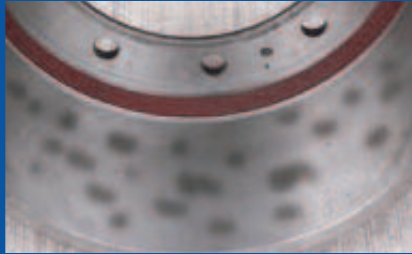
## Martensite Spotted Drums

This problem presents itself as hard, slightly raised dark coloured spots on the braking surface, with uneven wear. A significant characteristic is a pulsating brake pedal, combined with excessive noise. This condition indicates that the drum has been subjected to extremely high temperatures. These extremely high temperatures have caused structural changes to occur in the brake drum material which will make the drum more susceptible to cracking. If this condition exists, both the brake drum and linings must be replaced and the source of the overheating identified and remedied.

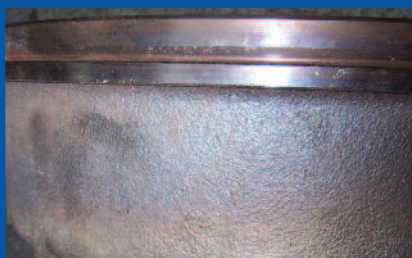
## Blued Brake Drums

This condition occurs when the drum has been subjected to extremely high temperatures. This may be caused by continued hard stops, by brake system imbalance, or faulty return springs. It is not always necessary to replace the drum as long as it is still within the tolerances for operation. To correct this problem the brake system should be checked for proper balance, the return springs should be inspected to ensure that they have neither become weak or broken and the brake shoe clearance should be checked and if necessary adjusted. If this condition is left unresolved it can result in either cracking or a martensite condition.

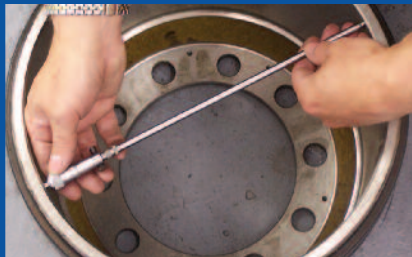
## Oval Drums

This condition exists when the drum diameter shows variations at different points around the braking surface and the brake linings exhibit more wear on one side than the other. This distortion of the drum as a result of excessive heat generated during brake applications or as a result of improper drum storage techniques (*see drum storage below*). Other possible causes for this condition include improper chucking of the drum during turning or it could be the result of dropping the drum on a hard surface during routine wheel-end maintenance.

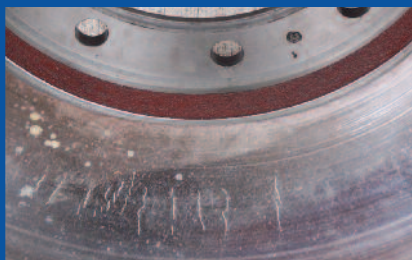
## Heat-Checks

Heat-checking presents itself as a number of short, fine, hairline cracks on the braking surface of the drum. Heat-checking is a normal characteristic found in brake drums and is caused by constant cooling and heating of the braking surface, which occurs when the brakes are applied during everyday operation of the vehicle. Normal heat-checking will not impair braking performance. Heat-checks will ordinarily wear away and reform as a result of the normal braking process, however heat-checks may progress over time into more serious cracks, which will require the brake drum to be replaced.

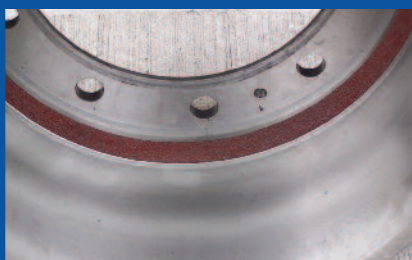
## Excessive Wear

If excessive wear occurs along the edges of the lining contact area of the braking surface or in area coinciding with the lining rivet holes, the system should be checked to make sure that there is not an abnormal build-up of abrasive material.

The most common cause of this problem is the build-up of abrasive material from either the presence or the absence of dust shields depending on the application of the vehicle. If the problem occurs while dust shields are installed, remove the lower dust shield to allow abrasive materials to more readily exit the braking system. If the problem occurs while dust shields are not employed, install dust shields to restrict abrasive materials from entering the brake system. Brake drums should also be checked for evidence of scoring.

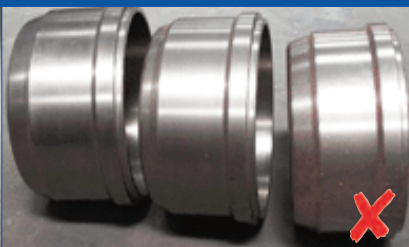
## Drum Storage

**Incorrect drum storage**  
Storing drums incorrectly may result in ovality of the drum and cause premature brake failure.

**Correct drum storage**  
Drums should be stacked in the way shown. This ensures proper distribution of weight on the sidewalls of the drum and will avoid damage to the drum.
