# Brake Discs with ABS Rings: Sensor Damage

BULLETIN #JO19

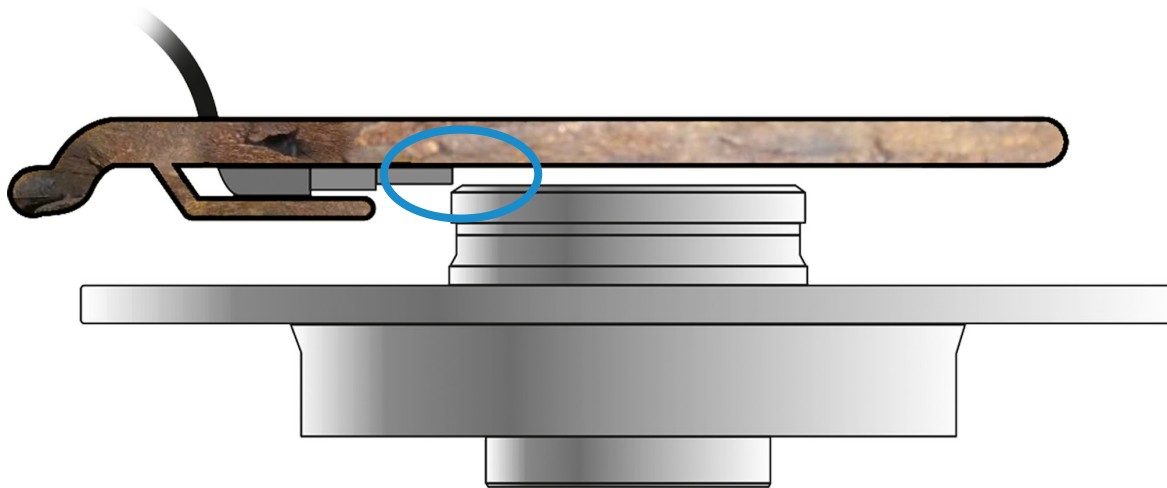
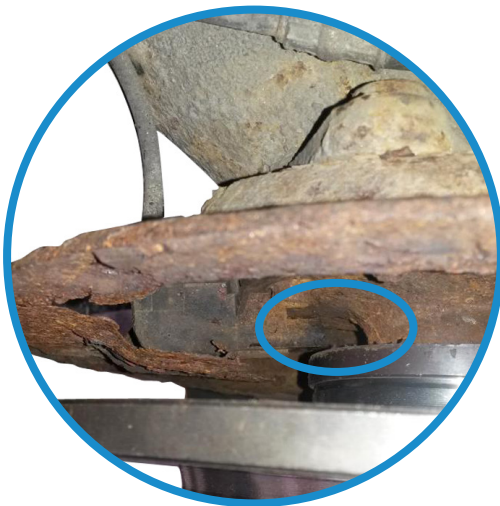
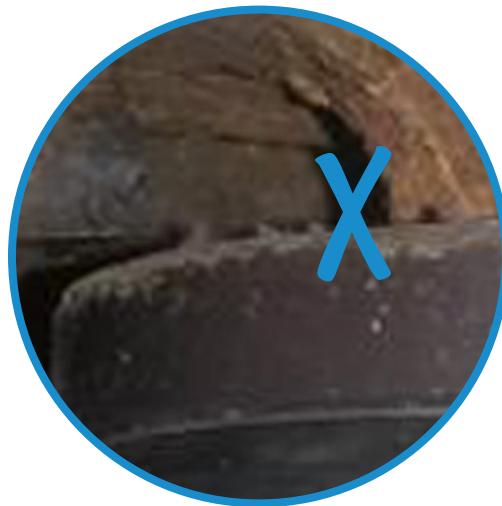
When changing brake discs that have an ABS sensor fitted, the disc can at times touch the ABS sensor. If the disc is pushed all the way in, it can bend the sensor and the magnetic sensor ring can become damaged.

The ABS sensor is being forced away from its correct position by rust build up behind it on the dust cover plate.

It is advised to remove the sensor and clean away any corrosion. However, if the corrosion is too severe, it may be necessary to fit a new dust cover plate.
