# Explained: Unusual Wear Patterns and Excessive Noise on JCP4263

Counter weight / damper not fitted to caliper

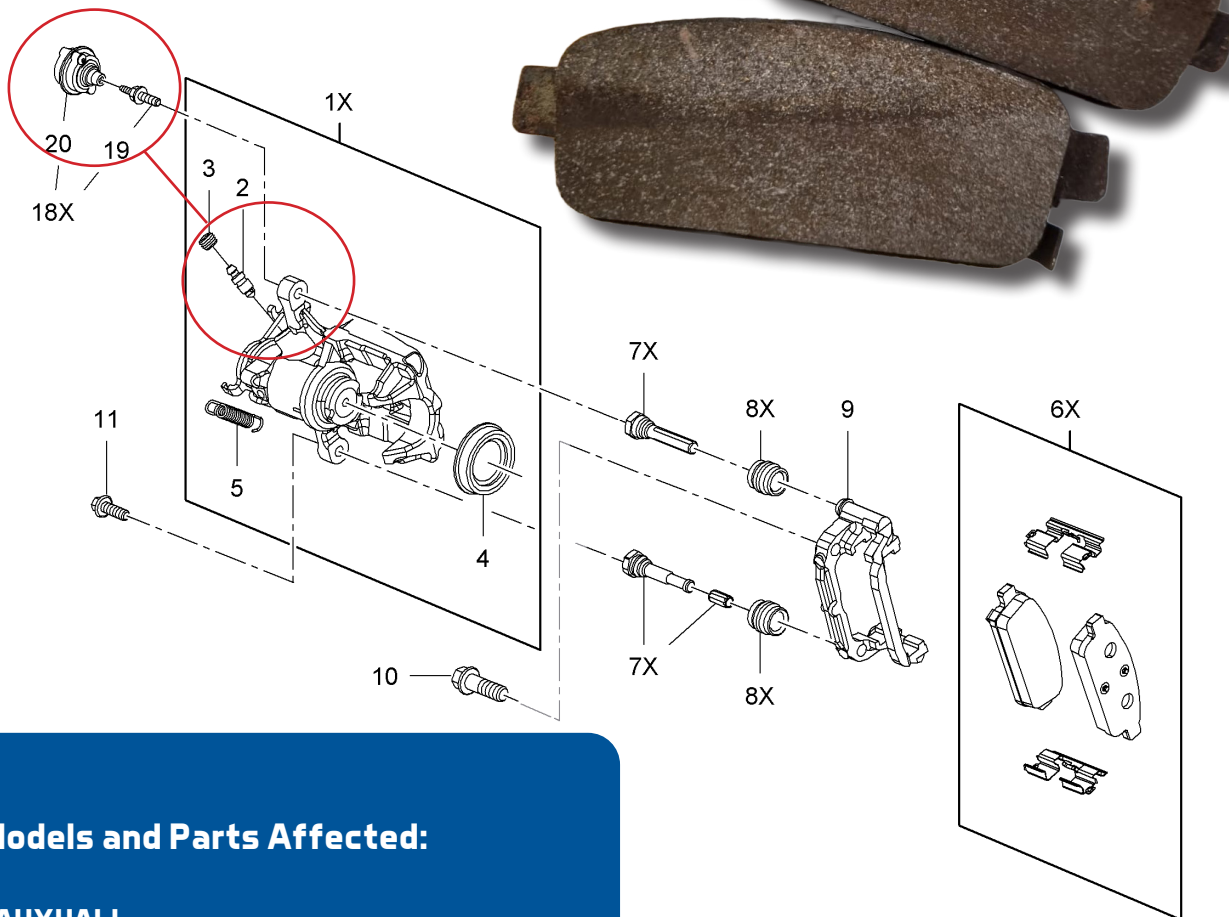
Various models have a counter weight / damper fitted to the rear caliper as shown below. If this part is not fitted, it can cause unusual wear patterns on the brake pad and excessive noise during braking.

The old caliper should have this part fitted, if this isn't present or is damaged, the OE Part number required is: **13337450** (1605260, 42372987, 1605315)
